Statistical Correlation of Observed
Ground Motion with Low-Rise
Building Damage: Project Rulison,
January 1973

Statistical Correlation of Observed Ground Motion with Low-Rise Building Component Damage : Project RULISON

by
R. E. Scholl
and
I. Farhoomand

John A. Blume & Associates
Research Division
San Francisco, California

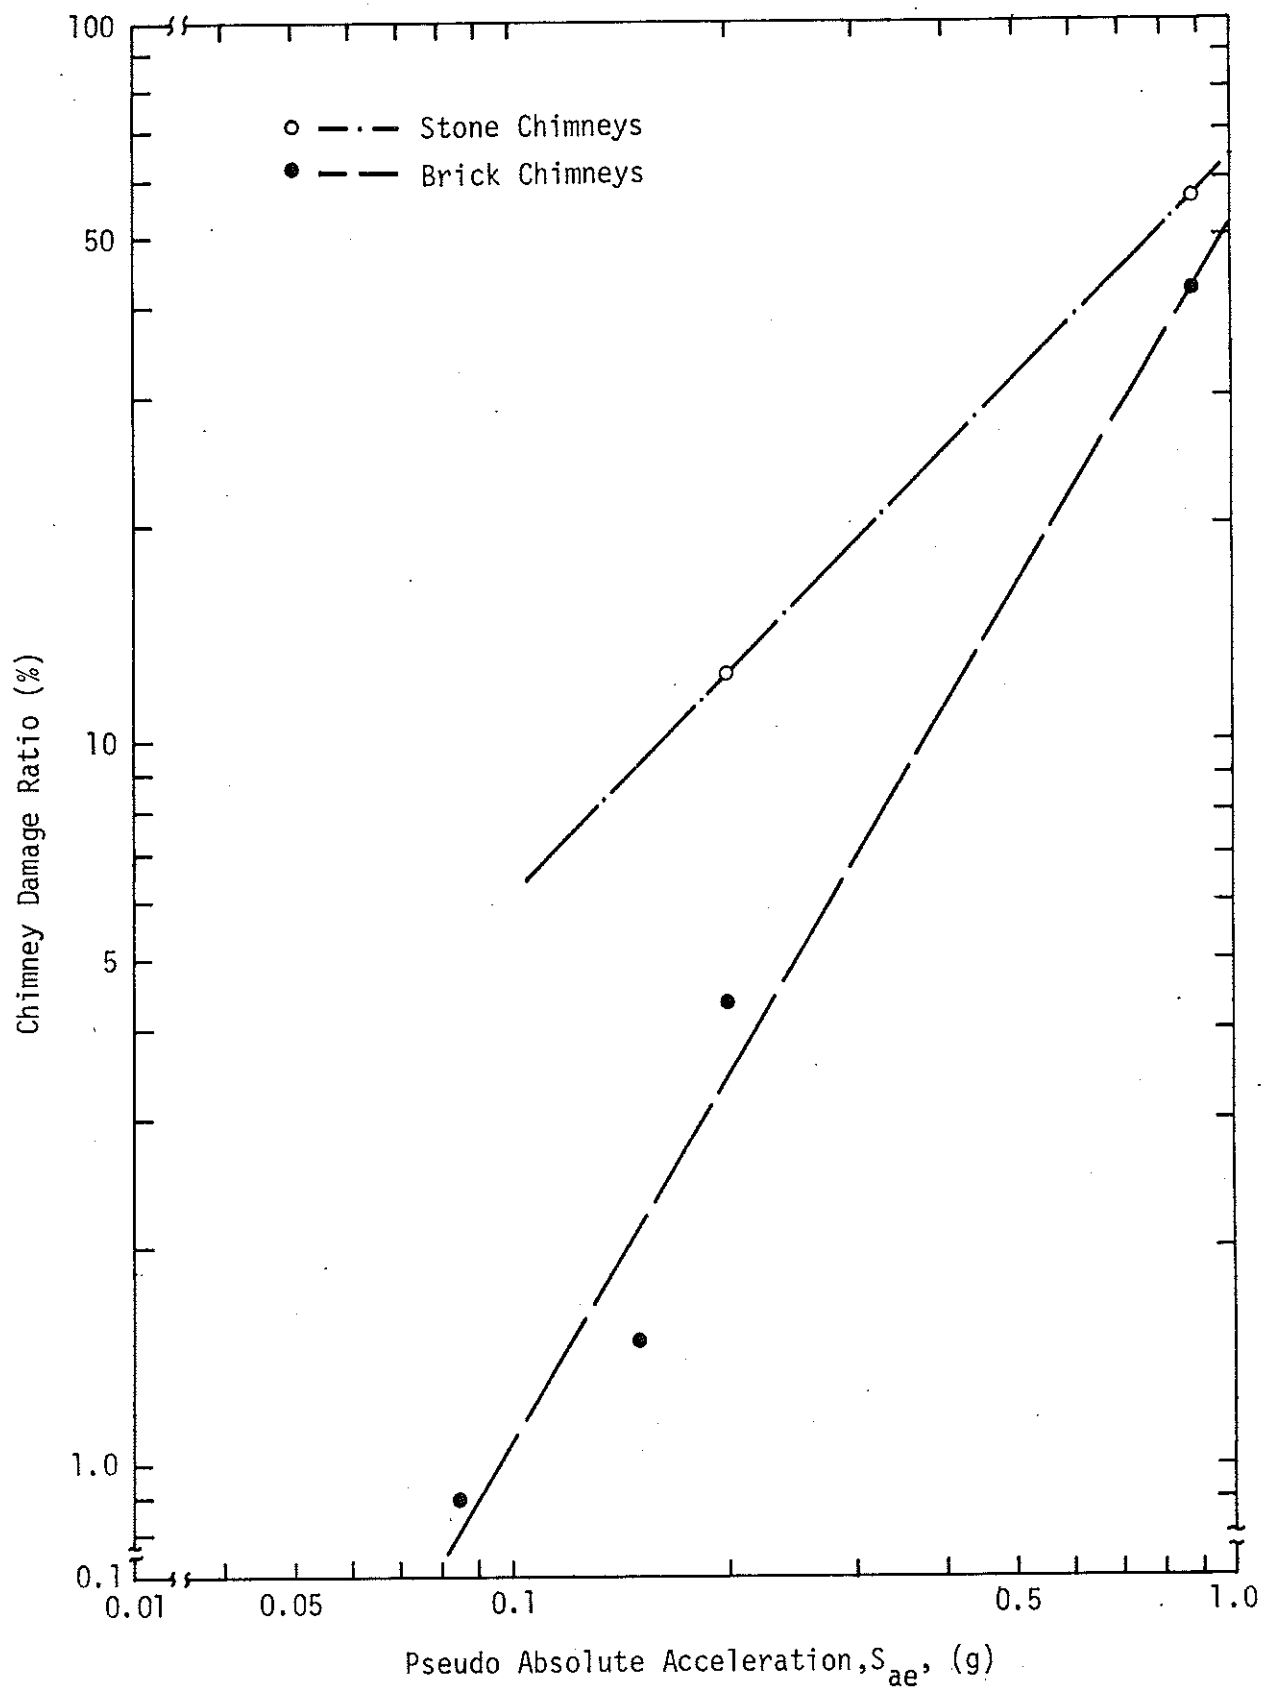
FIGURE 12 CHIMNEY DAMAGE RATIO (BY CHIMNEY TYPE) VS SPECTRAL INTENSITY

Because there are only two data points for stone chimneys, the line drawn through them is not reliable for quantitative analysis, but the data are useful for qualitative comparison. The figure indicates that stone chimneys have a lower damage threshold* than brick chimneys. This observation is consistent with that of a similar study⁶ conducted correlating residential building damage with ground motion resulting from the San Fernando, California, earthquake of February 9, 1971.

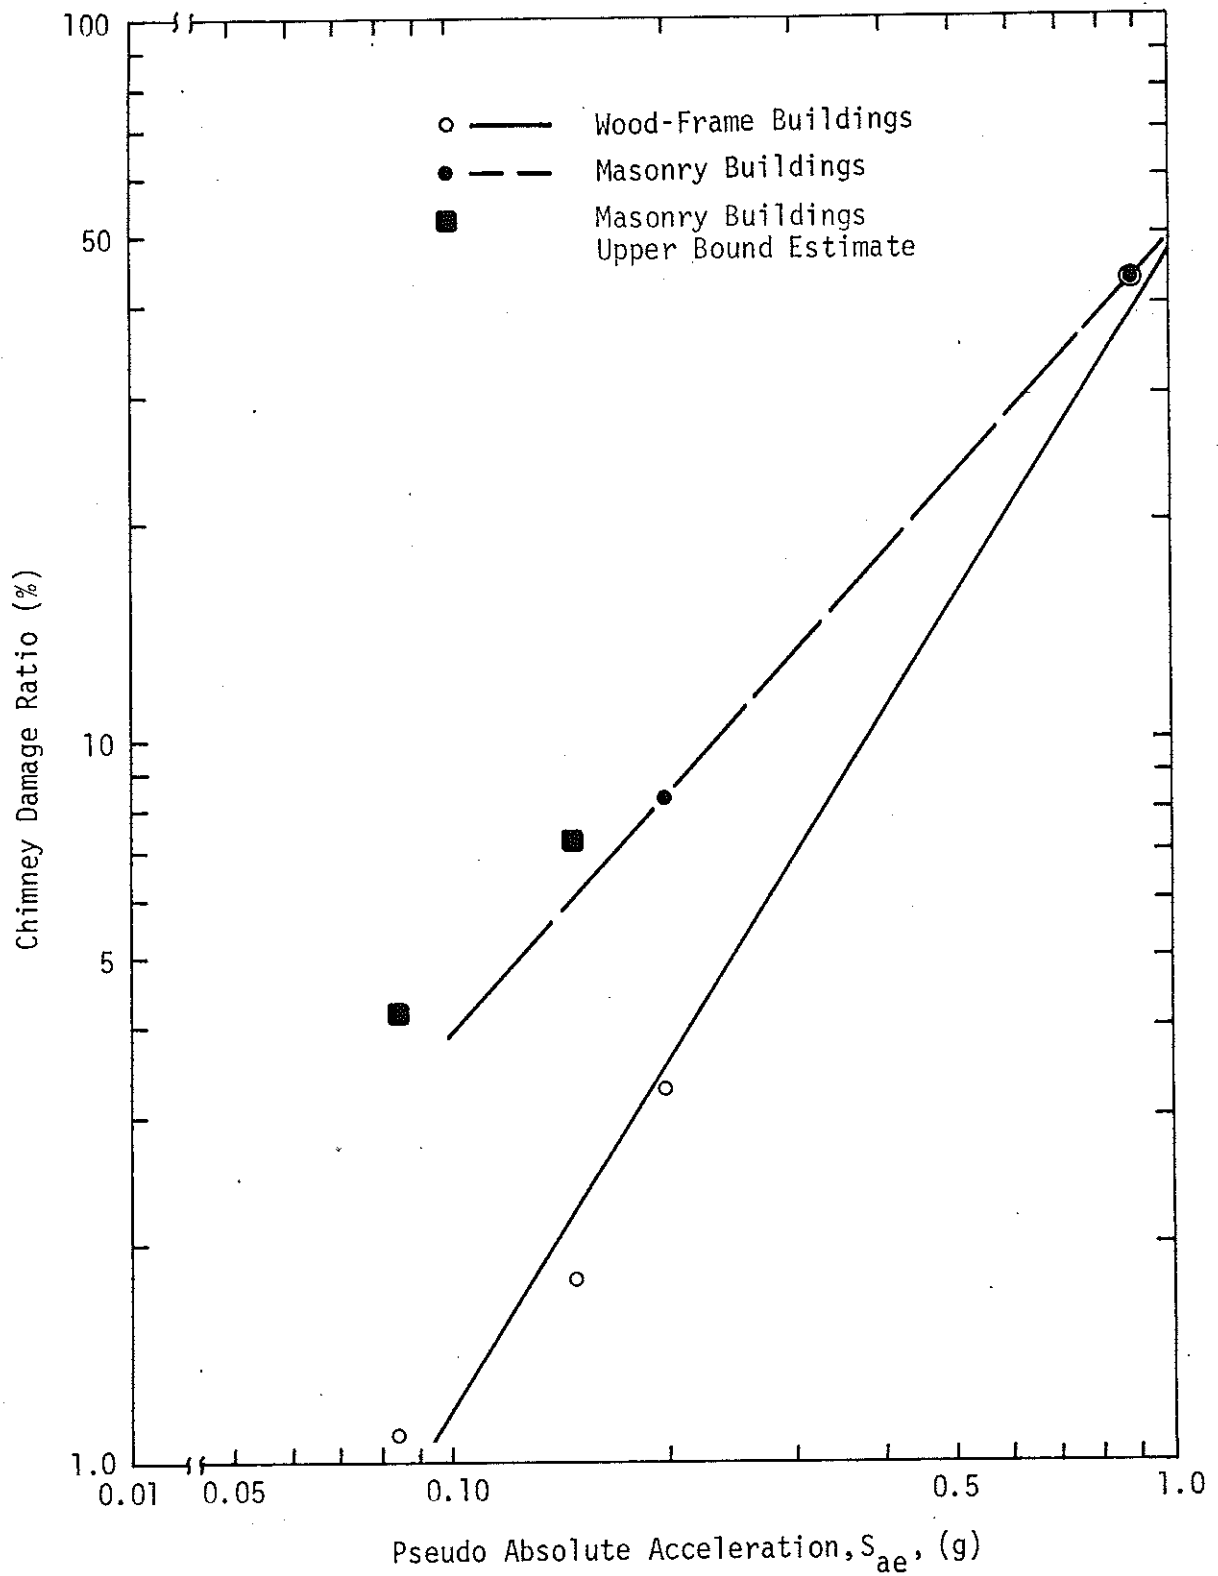
FIGURE 13 CHIMNEY DAMAGE RATIO (BY BUILDING TYPE) VS SPECTRAL INTENSITY

Although the number of data points for Group 1 and masonry buildings is inadequate for quantitative evaluation, the data are useful for qualitative comparison. Figure 13 shows that for low spectral intensity, chimneys in masonry buildings have lower damage thresholds than chimneys in wood-frame buildings, but that as spectral intensity increases, the difference in damage ratio decreases. Figure 14 does not indicate a substantial difference in the motion-damage relationships for chimneys in Group 1 and Group 2 buildings.

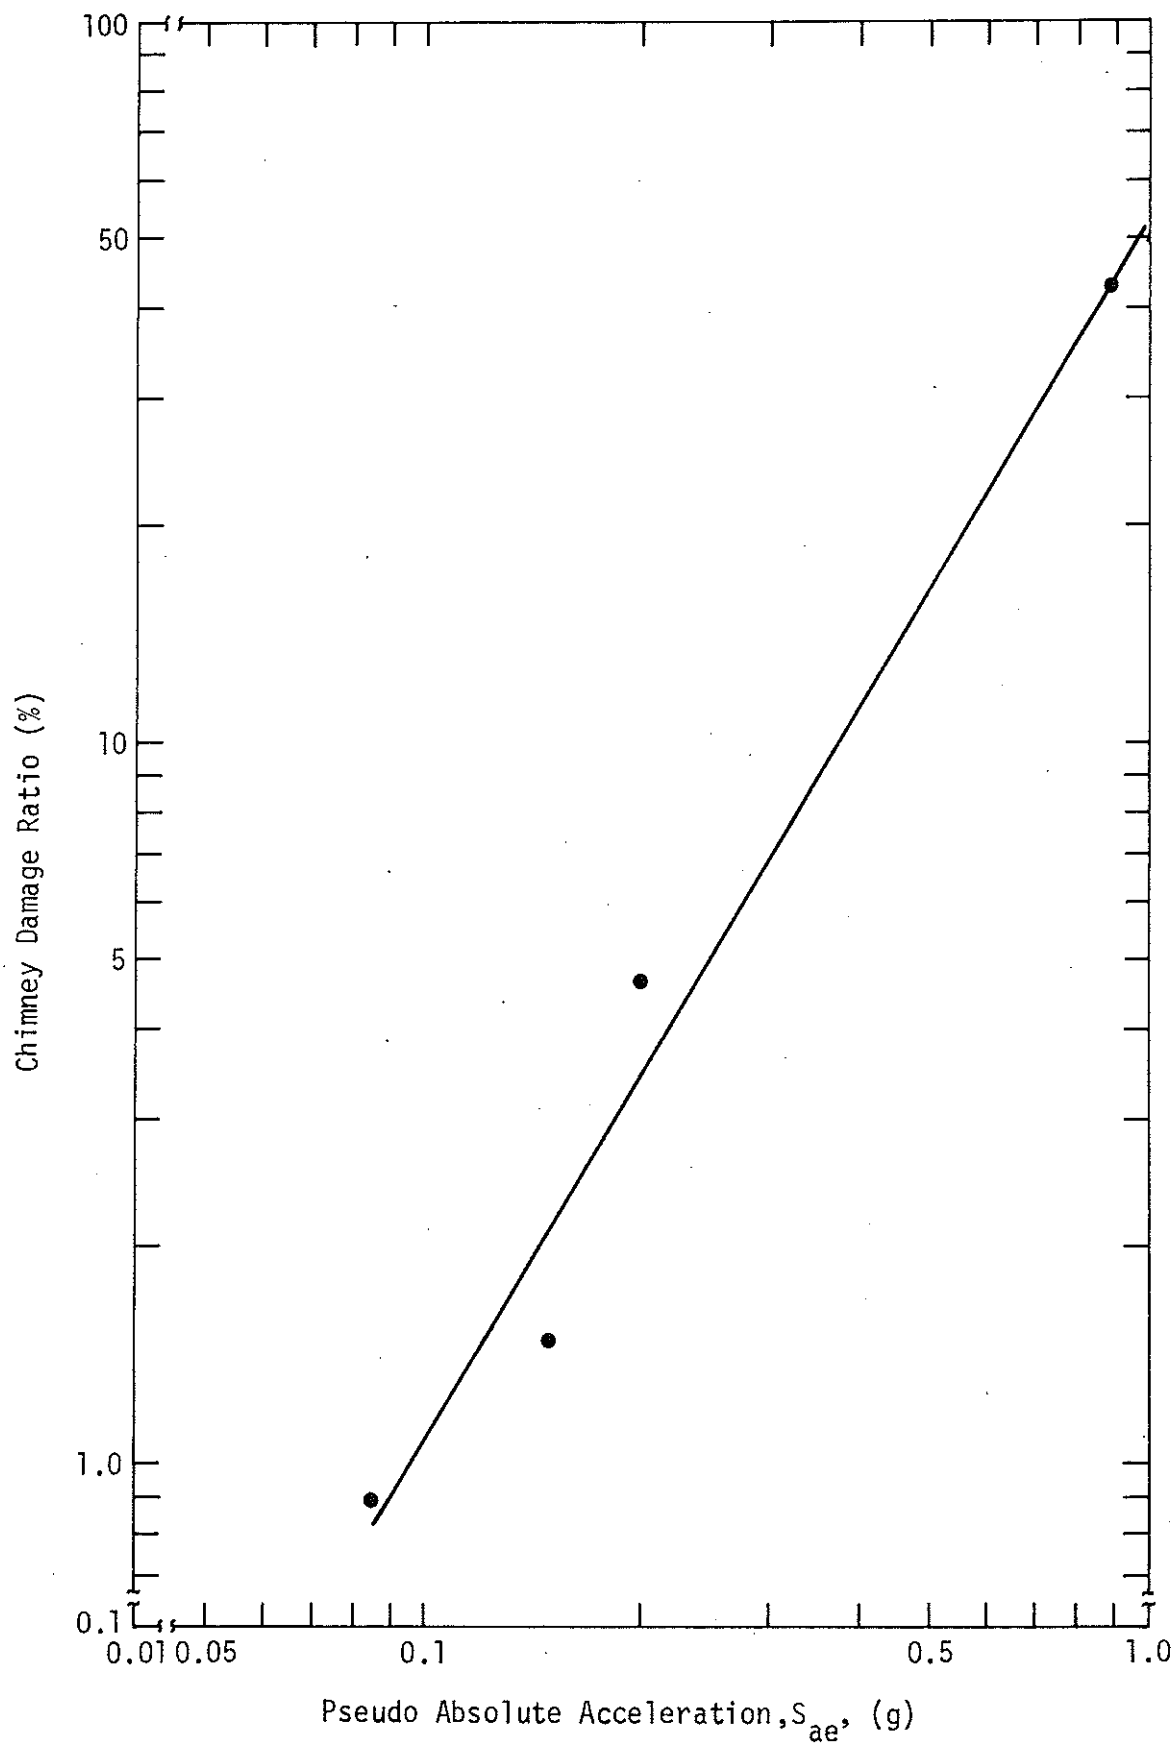
FIGURE 15 CHIMNEY DAMAGE RATIO (FOR ALL BUILDINGS WITH CHIMNEYS) VS SPECTRAL INTENSITY

The variation of damage ratio for all chimneys with spectral motion intensity S_{ae} is shown in Figure 15. The figure shows that approximately 1% of the chimneys subjected to a spectral acceleration intensity $S_{ae} \approx 0.1g$ will be damaged. Similarly, for a spectral acceleration intensity $S_{ae} \approx 1.0g$, more than 50% of the chimneys are expected to be damaged.

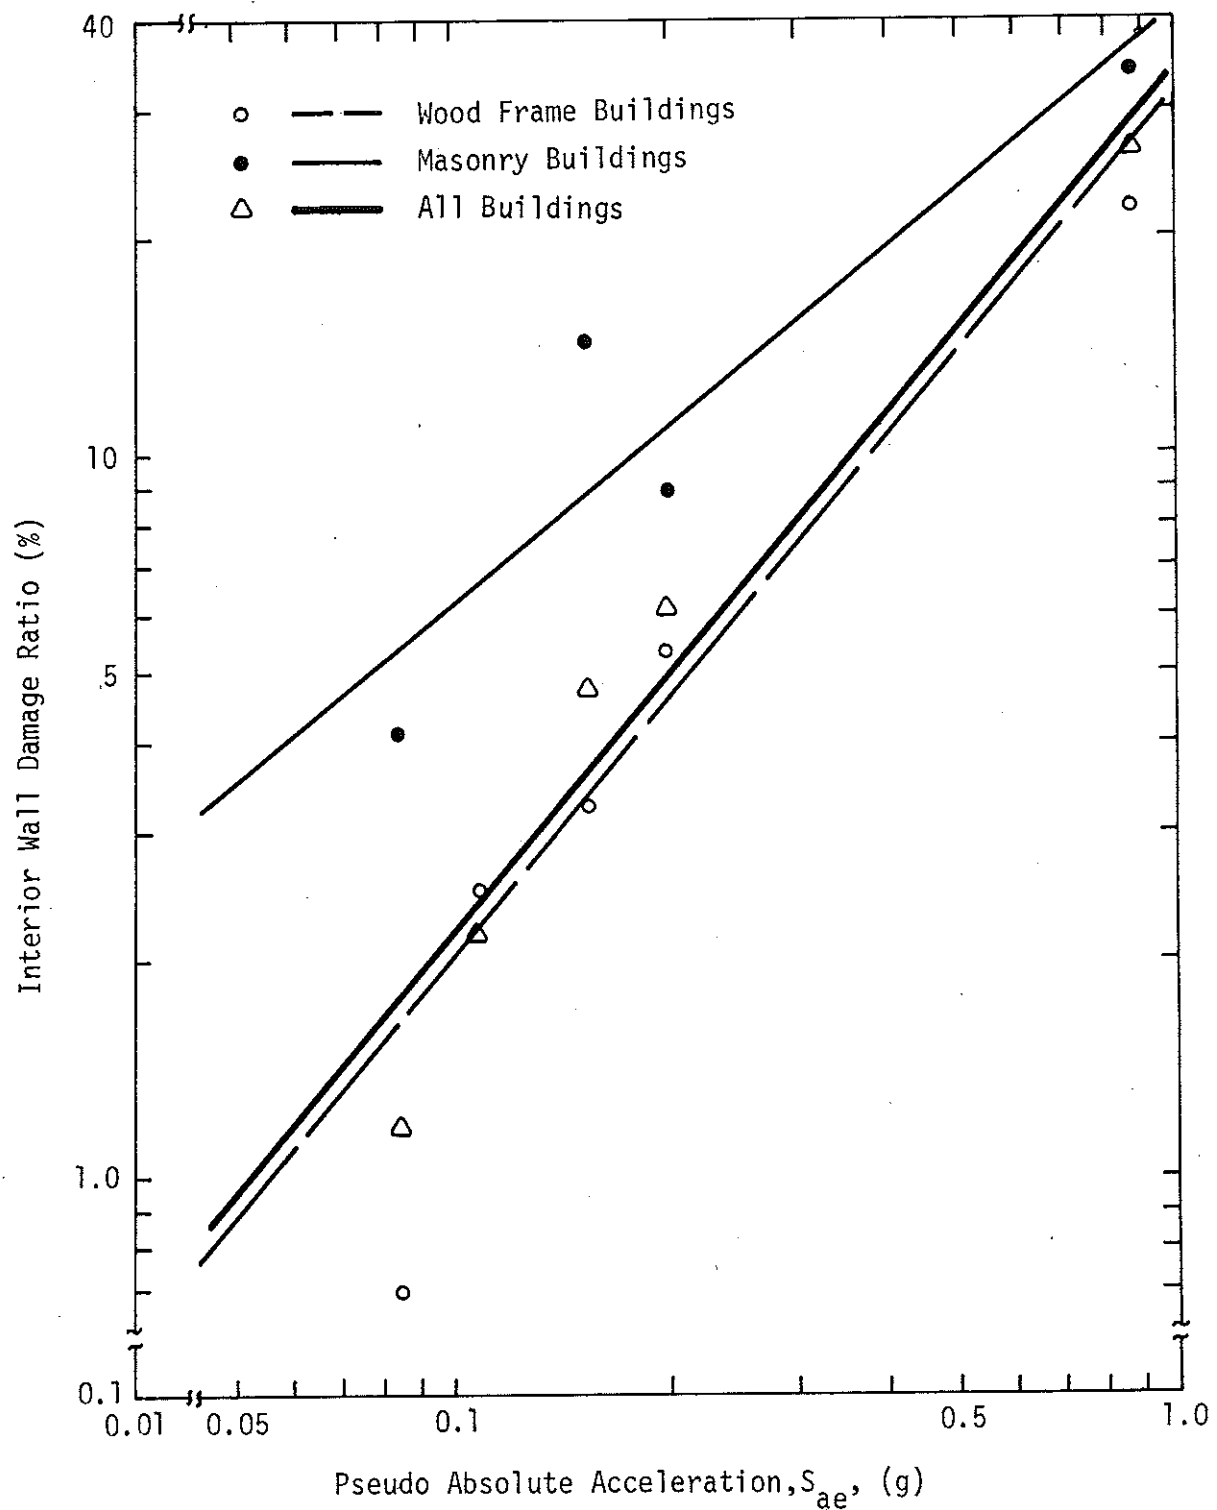
FIGURE 16 DAMAGE RATIO FOR INTERIOR WALLS
(BY BUILDING TYPE) VS SPECTRAL INTENSITY

Table 6 presents the damage ratios of interior walls for the various building groups in the five towns. The plots of damage ratio for walls in masonry and wood-frame buildings (Figure 16) indicate that interior walls in masonry buildings are more susceptible to damage than interior walls in wood-frame buildings, although the difference decreases as the spectral intensity increases. Figure 17 shows the variation of damage ratio of interior walls for the two building groups with spectral intensity S_{ae} . These two figures suggest that the interior walls of the masonry buildings and Group 2 buildings have the lowest and the highest damage thresholds, respectively.

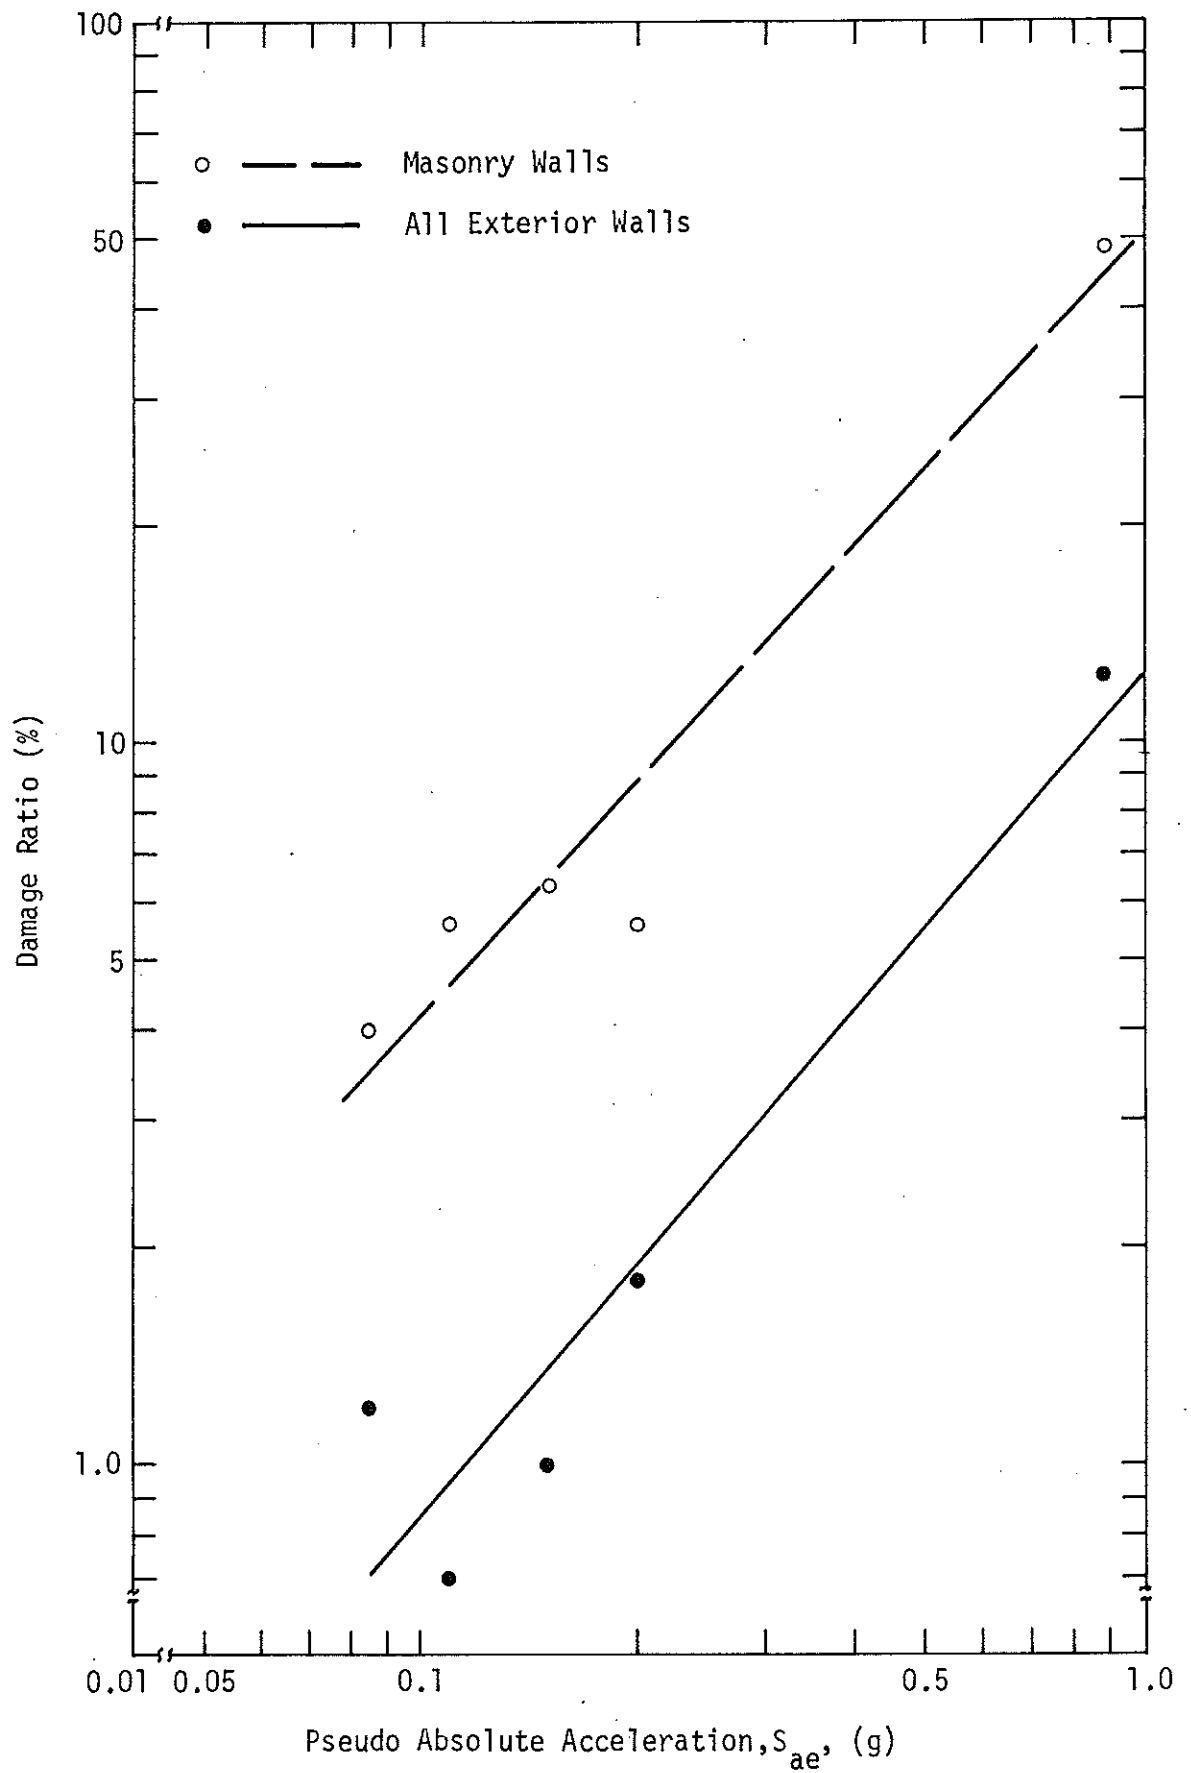
FIGURE 18 DAMAGE RATIO FOR MASONRY WALLS AND EXTERIOR WALLS VS SPECTRAL INTENSITY

Figure 18 shows the increase of masonry wall damage with increase of spectral intensity. It indicates that masonry walls are highly susceptible to damage and that at a high spectral intensity, $S_{ae} = 1g$, more than 50% of masonry walls may be damaged. The second line in Figure 18 was plotted considering all damaged exterior walls, irrespective of type. Comparing the two lines, it

can be concluded that nonmasonry walls have higher damage thresholds than masonry walls.

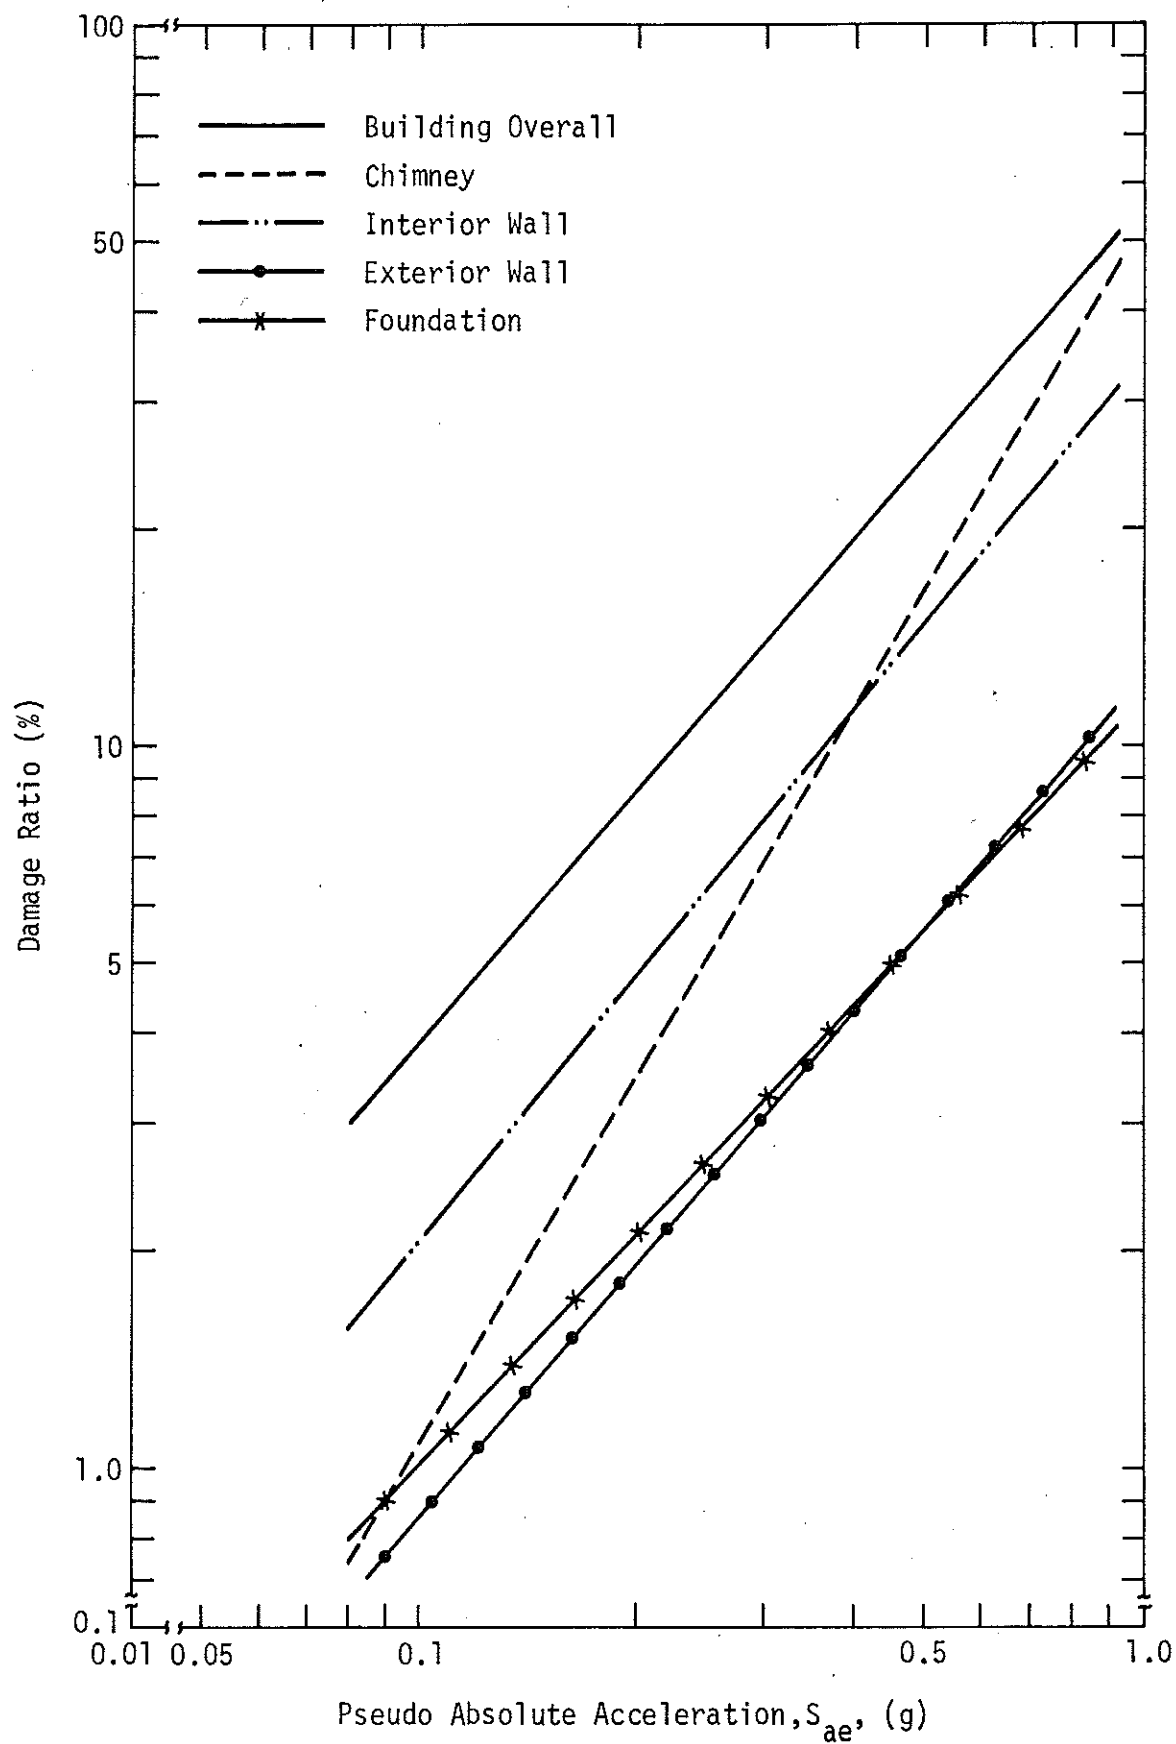
FIGURE 20 DAMAGE RATIOS FOR VARIOUS BUILDING COMPONENTS VS SPECTRAL INTENSITY

Summaries of the motion-damage relationships derived are shown in Figure 20. The figure shows the damage ratio variations with spectral intensity for the low-rise building components: chimney, interior wall, exterior wall, and foundation. For reference, the damage ratio variation with spectral intensity for overall building damage ratio which includes all types of damage is also given. To obtain these damage ratios, the number of damaged buildings, the number of buildings with interior wall damage, the number of buildings with foundation damage, and the number of buildings with exterior wall damage were normalized with respect to the total number of buildings; the number of buildings with chimney damage were normalized to the number of buildings with chimneys. The spectral intensity values were obtained by averaging the appropriate 5% damped pseudo absolute acceleration spectra over the period band 0.05 to 0.2 seconds.

Although the regression lines shown in Figure 20 have been derived from a limited number of sample points, they provide useful information concerning the relative damage susceptibility of particular low-rise building components. The figure shows that foundations are damage-resistant elements compared with chimneys and interior walls (mostly plaster coated). Chimneys sustain less damage than wall components at low spectral intensities ($S_{ae} < 0.25g$), but the chimney damage ratio increases rapidly in the moderate spectral intensity range ($0.25g < S_{ae} < 1.0g$).

Because of the significance of and the potential hazard resulting from chimney damage at spectral intensities of $S_{ae} \rightarrow 1.0g$, more detailed study of chimney damage was performed. Correlation results indicated that for the same spectral intensity, the damage ratio for uncapped chimneys is higher than for capped chimneys. The study also indicated that chimney damage increases with the increase of chimney height above the roof line.
